REPORT DOCUMENTATION PAGE		READ INSTRUCTIONS BEFORE COMPLETING FORM
1. REPORT NUMBER	2. GOVT ACCLSSION NO.	3. RECIPIENT'S CATALOG NUMBER
AD A092225		
4. TITLE (and Subtitle) Phase I Inspection Report Beaver Dam Lake Hudson River Basin, Orange County, New York Inventory No. 619		5. TYPE OF REPORT & PERIOD COVERED Phase I Inspection Report National Dam Safety Program

PHASE I INSPECTION REPORT
NATIONAL DAM SAFETY PROGRAM
BEAVER DAM LAKE
I.D. NO. N.Y. 619
D.E.C. #502
HUDSON RIVER BASIN
ORANGE COUNTY, NEW YORK

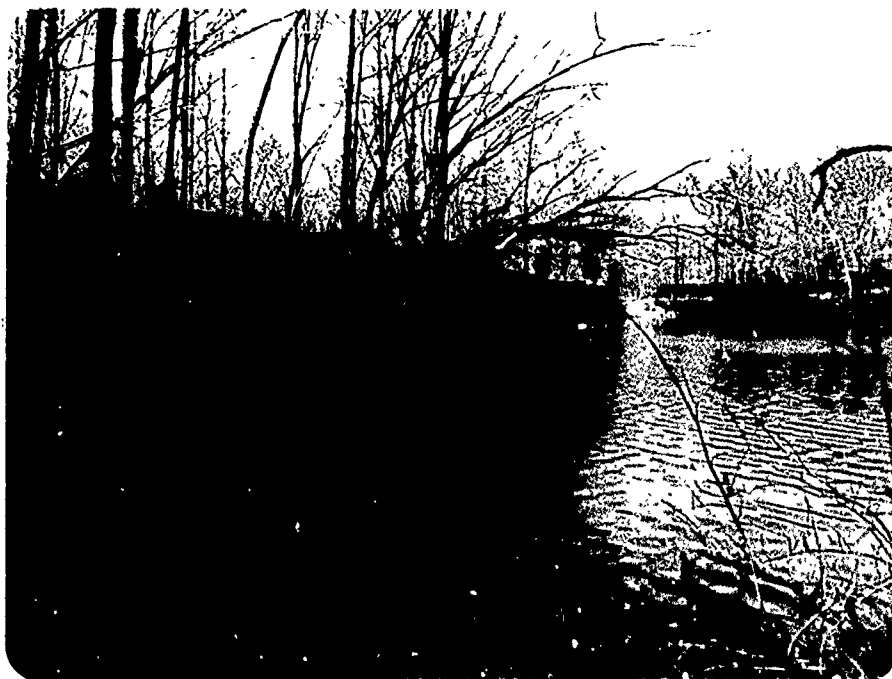
The upstream brick facing is in good condition above the water line except at several locations where the mortar at the joints is loose and missing. The downstream face of the wall is heavily spalled, particularly at the east wing of the dam (See Photograph 12).

2. VIEWS OF UPSTREAM FACE OF DAM.

- e. Loose and missing pointing at the upstream face of the dam and the spillway training walls should be repaired.
- f. The right and middle training walls should be repaired.
